MEMO FOR RECORD

SUBJECT: Freezeup Ice Jam at Hardwick,

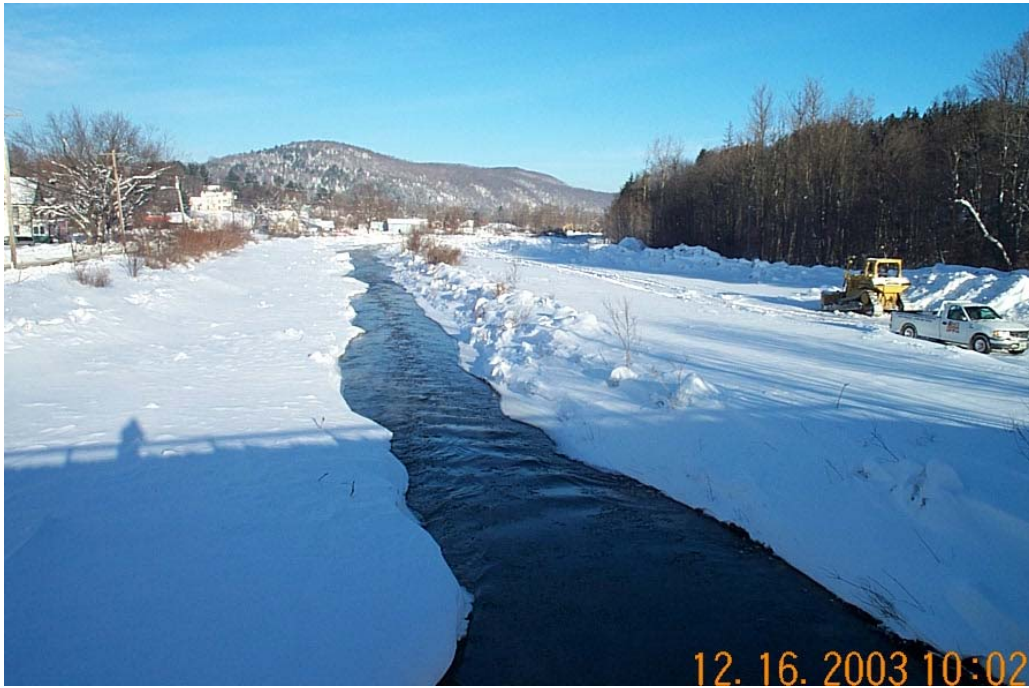
Fig. 5. Free flowing channel excavated through freezeup ice jam below Cottage St. Bridge at Hardwick, VT. The righthand floodplain has also been cleared of ice debris.

The town responded by digging a 0.6-mile-long channel through the ice jam using two large excavators. The channel extends from the Cottage St. Bridge to a point about 500 feet downstream of the railroad bridge. Below the Cottage St. Bridge, the channel is about 10 ft wide and running well at about 3-4 ft/s (Fig. 5). The ice removed from the channel has been cleared from the right hand floodplain to provide additional flow relief in anticipation of higher discharges and breakup. Between the snowmobile bridge and the railroad bridge the river is deeper and wider making it more difficult to excavate a well-defined channel to convey the frazil (Fig. 6). Dan Hill said that the ice congestion in this section is also aggravated by frazil flowing in from Cooper Brook, just upstream. Downstream of the railroad bridge, water velocity is higher again, and the frazil was moving well until it reached the backwater of Jackson Dam (Fig. 7).

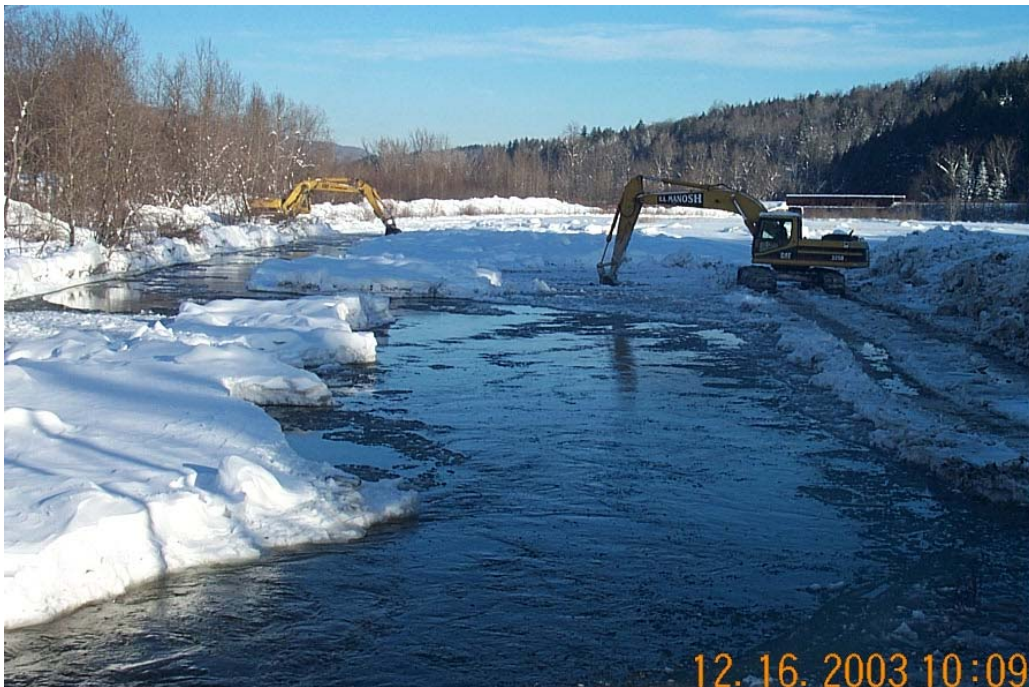
Fig. 6. Excavators removing ice downstream of the snowmobile bridge.

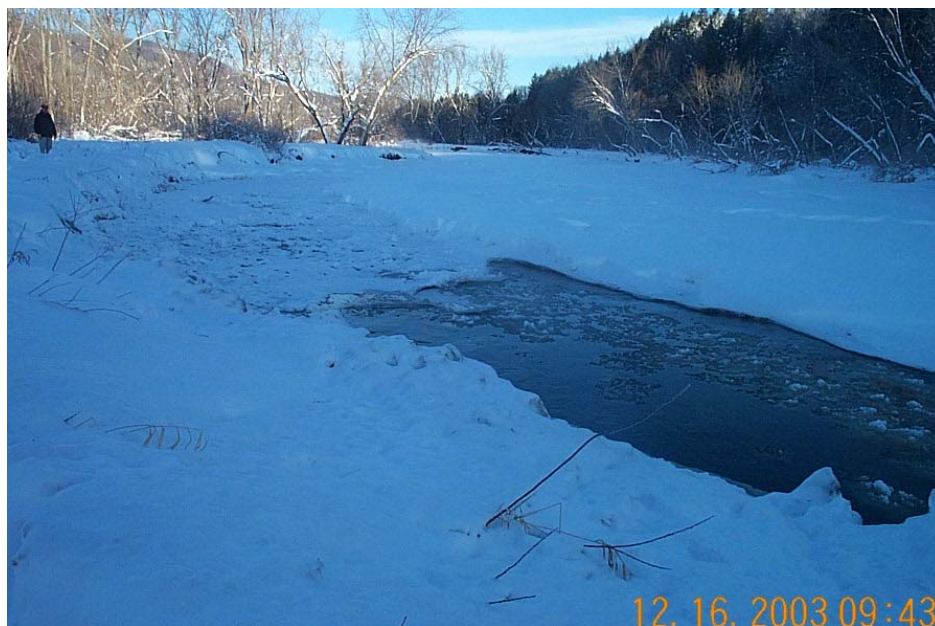
Fig. 7. Downstream end of the excavated channel, near the backwater of Hardwick Lake.
